**Re: Village of Los Lunas WWTP; UNPERMITTED DISCHARGE; SIC4952; NPDES  
Compliance Evaluation Inspection; NPDES NMU001943; August 22, 2017**

## NPDES Compliance Inspection Report

**Village of Los Lunas WWTP  
Compliance Evaluation Inspection  
NPDES Permit No. NMU001943  
August 22, 2017  
Further Explanations**

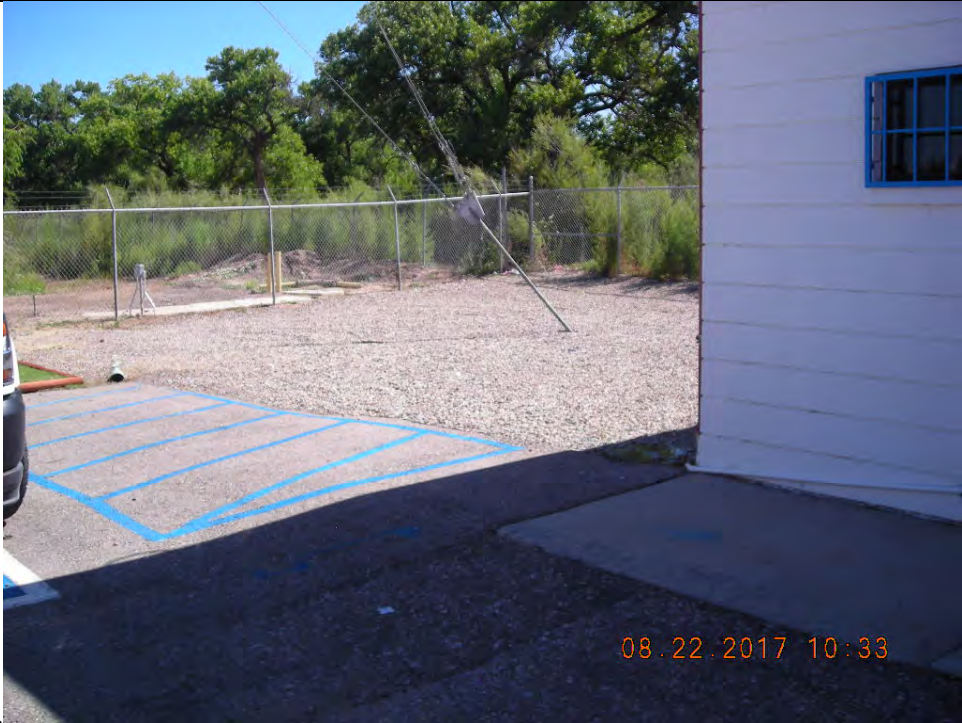
4. Water from ice machine condensate was discharging directly to the ground. This is not an allowable non-stormwater discharge under the permit. **The Facility responded on 9/18/17 that they had corrected this issue(see attachment 1).**

NMED/SWQB Official Photograph Log Photo # 1		
Photographer: Jennifer Foote	Date: 8/22/17	Time: 10:33
City/County: Los Lunas/Valencia County		State: New Mexico
Location: Los Lunas WWTF		
Subject: pipe from ice machine discharging to ground outside building

- Ice Machine Drain Line
  - We have disconnected and relocated the line to drain into the collection system.
- Pipe Connection Between the two (2) Drain Ponds

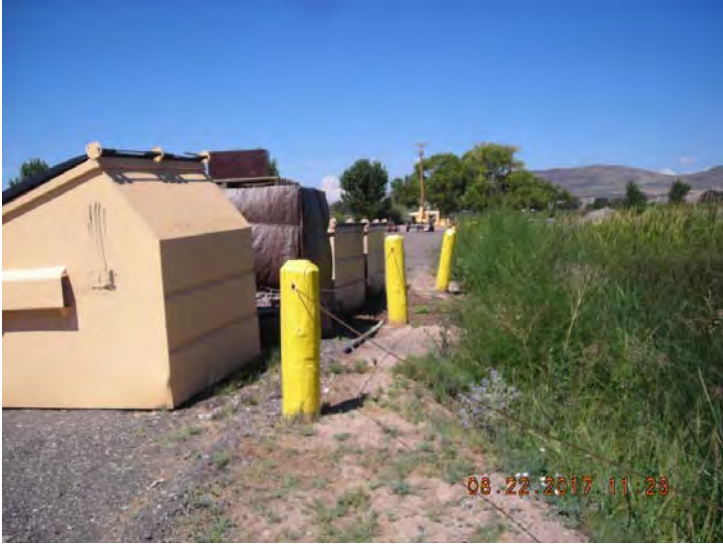
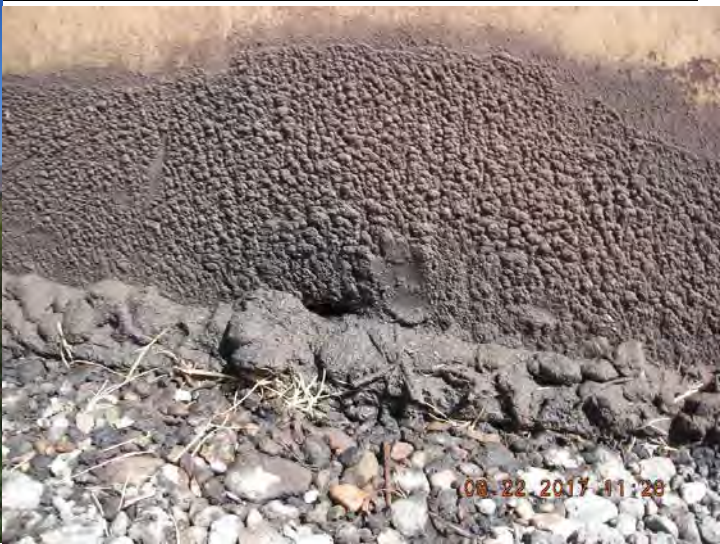
3. Waste oil storage was in metal containers sitting directly on the soil. There was staining on the soil adjacent to the bins and a hole in one of the containments. **The Facility responded on 9/18/17 that they were in the process of replacing the used oil storage (see attachment 1).**

NMED/SWQB Official Photograph Log Photo # 2 +3		
Photographer: Jennifer Foote	Date: 8/22/17	Time: 11:23 and 11:26
City/County: Los Lunas/Valencia County		State: New Mexico
Location: Los Lunas WWTF		
Subject: Leak at waste oil containment

- Our used oil storage tank is a little outdated and we are in the process of updating that storage system. I have ordered two (2) new double walled poly tanks, 150 gallon used oil tank and a 50 gallon used antifreeze tank. We will have the oil pumped out of the existing barrels, the dumpsters that house the barrels will be sent back to our Solid Waste Department to repair and seal them, so that there is no chance of leaking. We will bring back one dumpster to house the new

tanks. The refurbished dumpster will be painted and stenciled with USED OIL & WASTE FLUIDS.

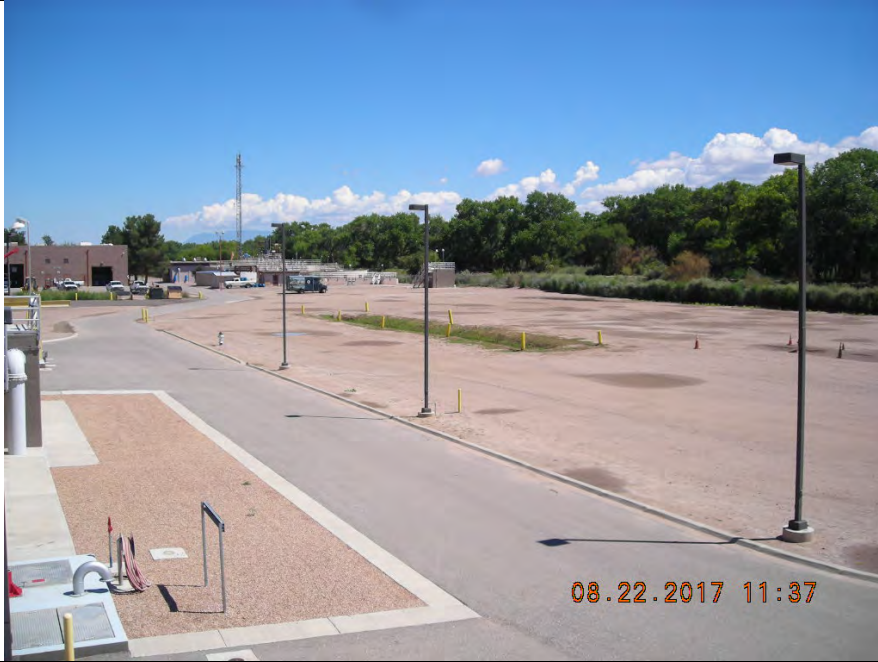
NMED/SWQB  
Official Photograph Log  
Photo # 4

2. It appears the facility has been designed to drain to four retention ponds. The facility stated that one pond had been removed near the blender box, but they weren't sure if the pipe connecting it to the central pond was removed or still in place. **The Facility responded on 9/18/17 that they were evaluating capping the pipe (see attachment 1).**

Subject: retention ponds

- We are evaluating to determine whether or not the pipe was capped on the side before it was buried, but we will also look into capping the exposed side of the pipe in the very near future.

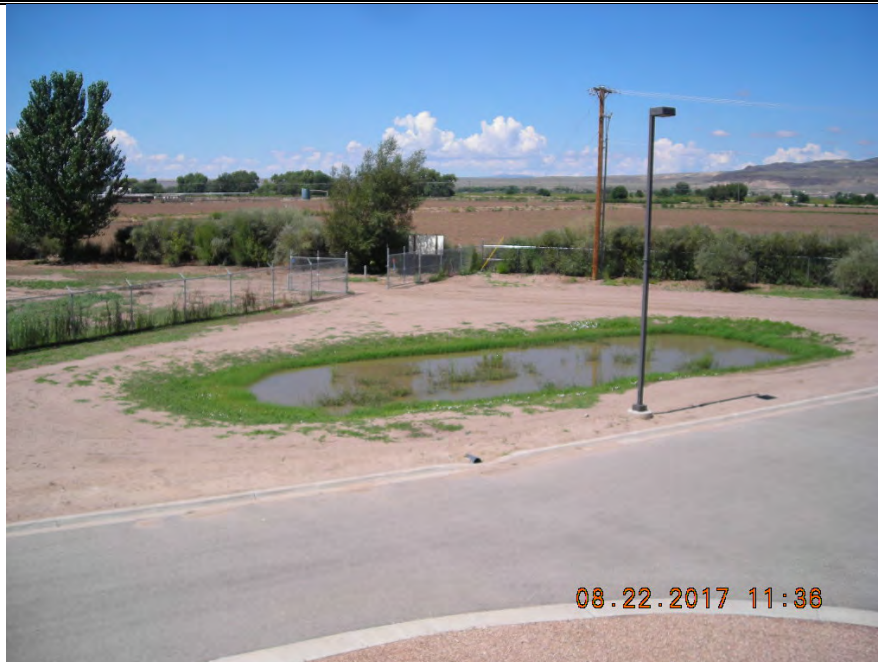
NMED/SWQB  
Official Photograph Log  
Photo # 5

Subject: retention ponds
